Environmental Impact Study

Glenelg Phase 3

Flato Developments Inc.

SLR Consulting (Canada) Ltd.

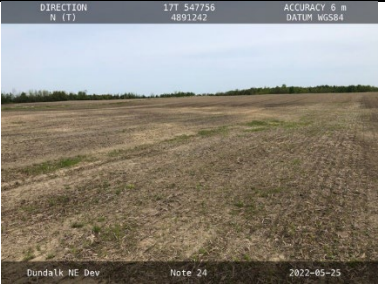
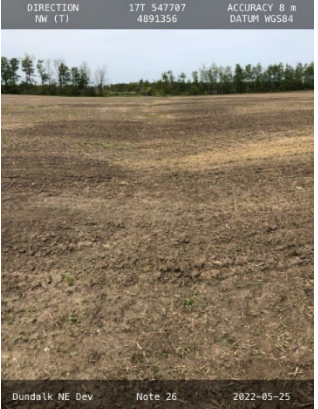
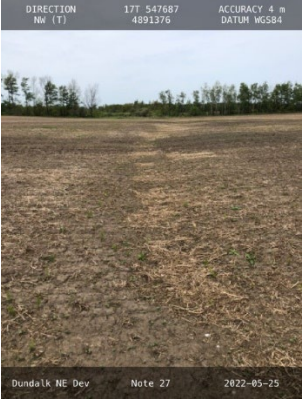
Drainage Feature Segment	Hydrology	Hydrology Modifiers	Riparian	Fish Habitat	Terrestrial Habitat	HDF Management Recommendations	Photos
1	Limited or recharge April: Standing Water May: Dry August: Dry	Swale (tilled through)	Limited Function Cropped land	Contributing function allochthonous transport	Limited Function Cropped land	No Management Required

2	Limited or recharge April: Standing Water May: Dry August: Dry	Swale (tilled through)	Limited Function Cropped land	Contributing function allochthonous transport	Limited Function Cropped land	No Management Required

3	Limited or recharge April: Standing Water May: Dry August: Dry	Swale (tilled through)	Limited Function Cropped land	Contributing function allochthonous transport	Limited Function Cropped land	No Management Required

Drainage Feature Segment	Hydrology	Hydrology Modifiers	Riparian	Fish Habitat	Terrestrial Habitat	HDF Management Recommendations	Photos
4	Limited or recharge April: Standing Water May: Dry August: Dry	Swale (tilled through)	Limited Function Cropped land	Contributing function allochthonous transport	Limited Function Cropped land	No Management Required

Observations made in April, May, and August 2022 to characterize potential headwater drainage feature associated with the proposed DPOS are summarized in Table 3. Surface water was observed at the feature during the April visit, while the feature was dry during subsequent visits. Standing water was present in the feature off site to the north during April and May visits and was dry in August. Based on these observations the assessment of the headwater drainage feature on the site of the proposed DPOS was classified as No Management Required, while the segment occurring immediately off site to the north was classified as Protection (Figure 3) according to the Headwater Features Guidelines (CVC and TRCA 2014). Management can range from replication of functions through enhanced lot level conveyance measures such as vegetated swales, to mimic online wet vegetation pockets, to constructed wetlands connected to downstream features as appropriate.

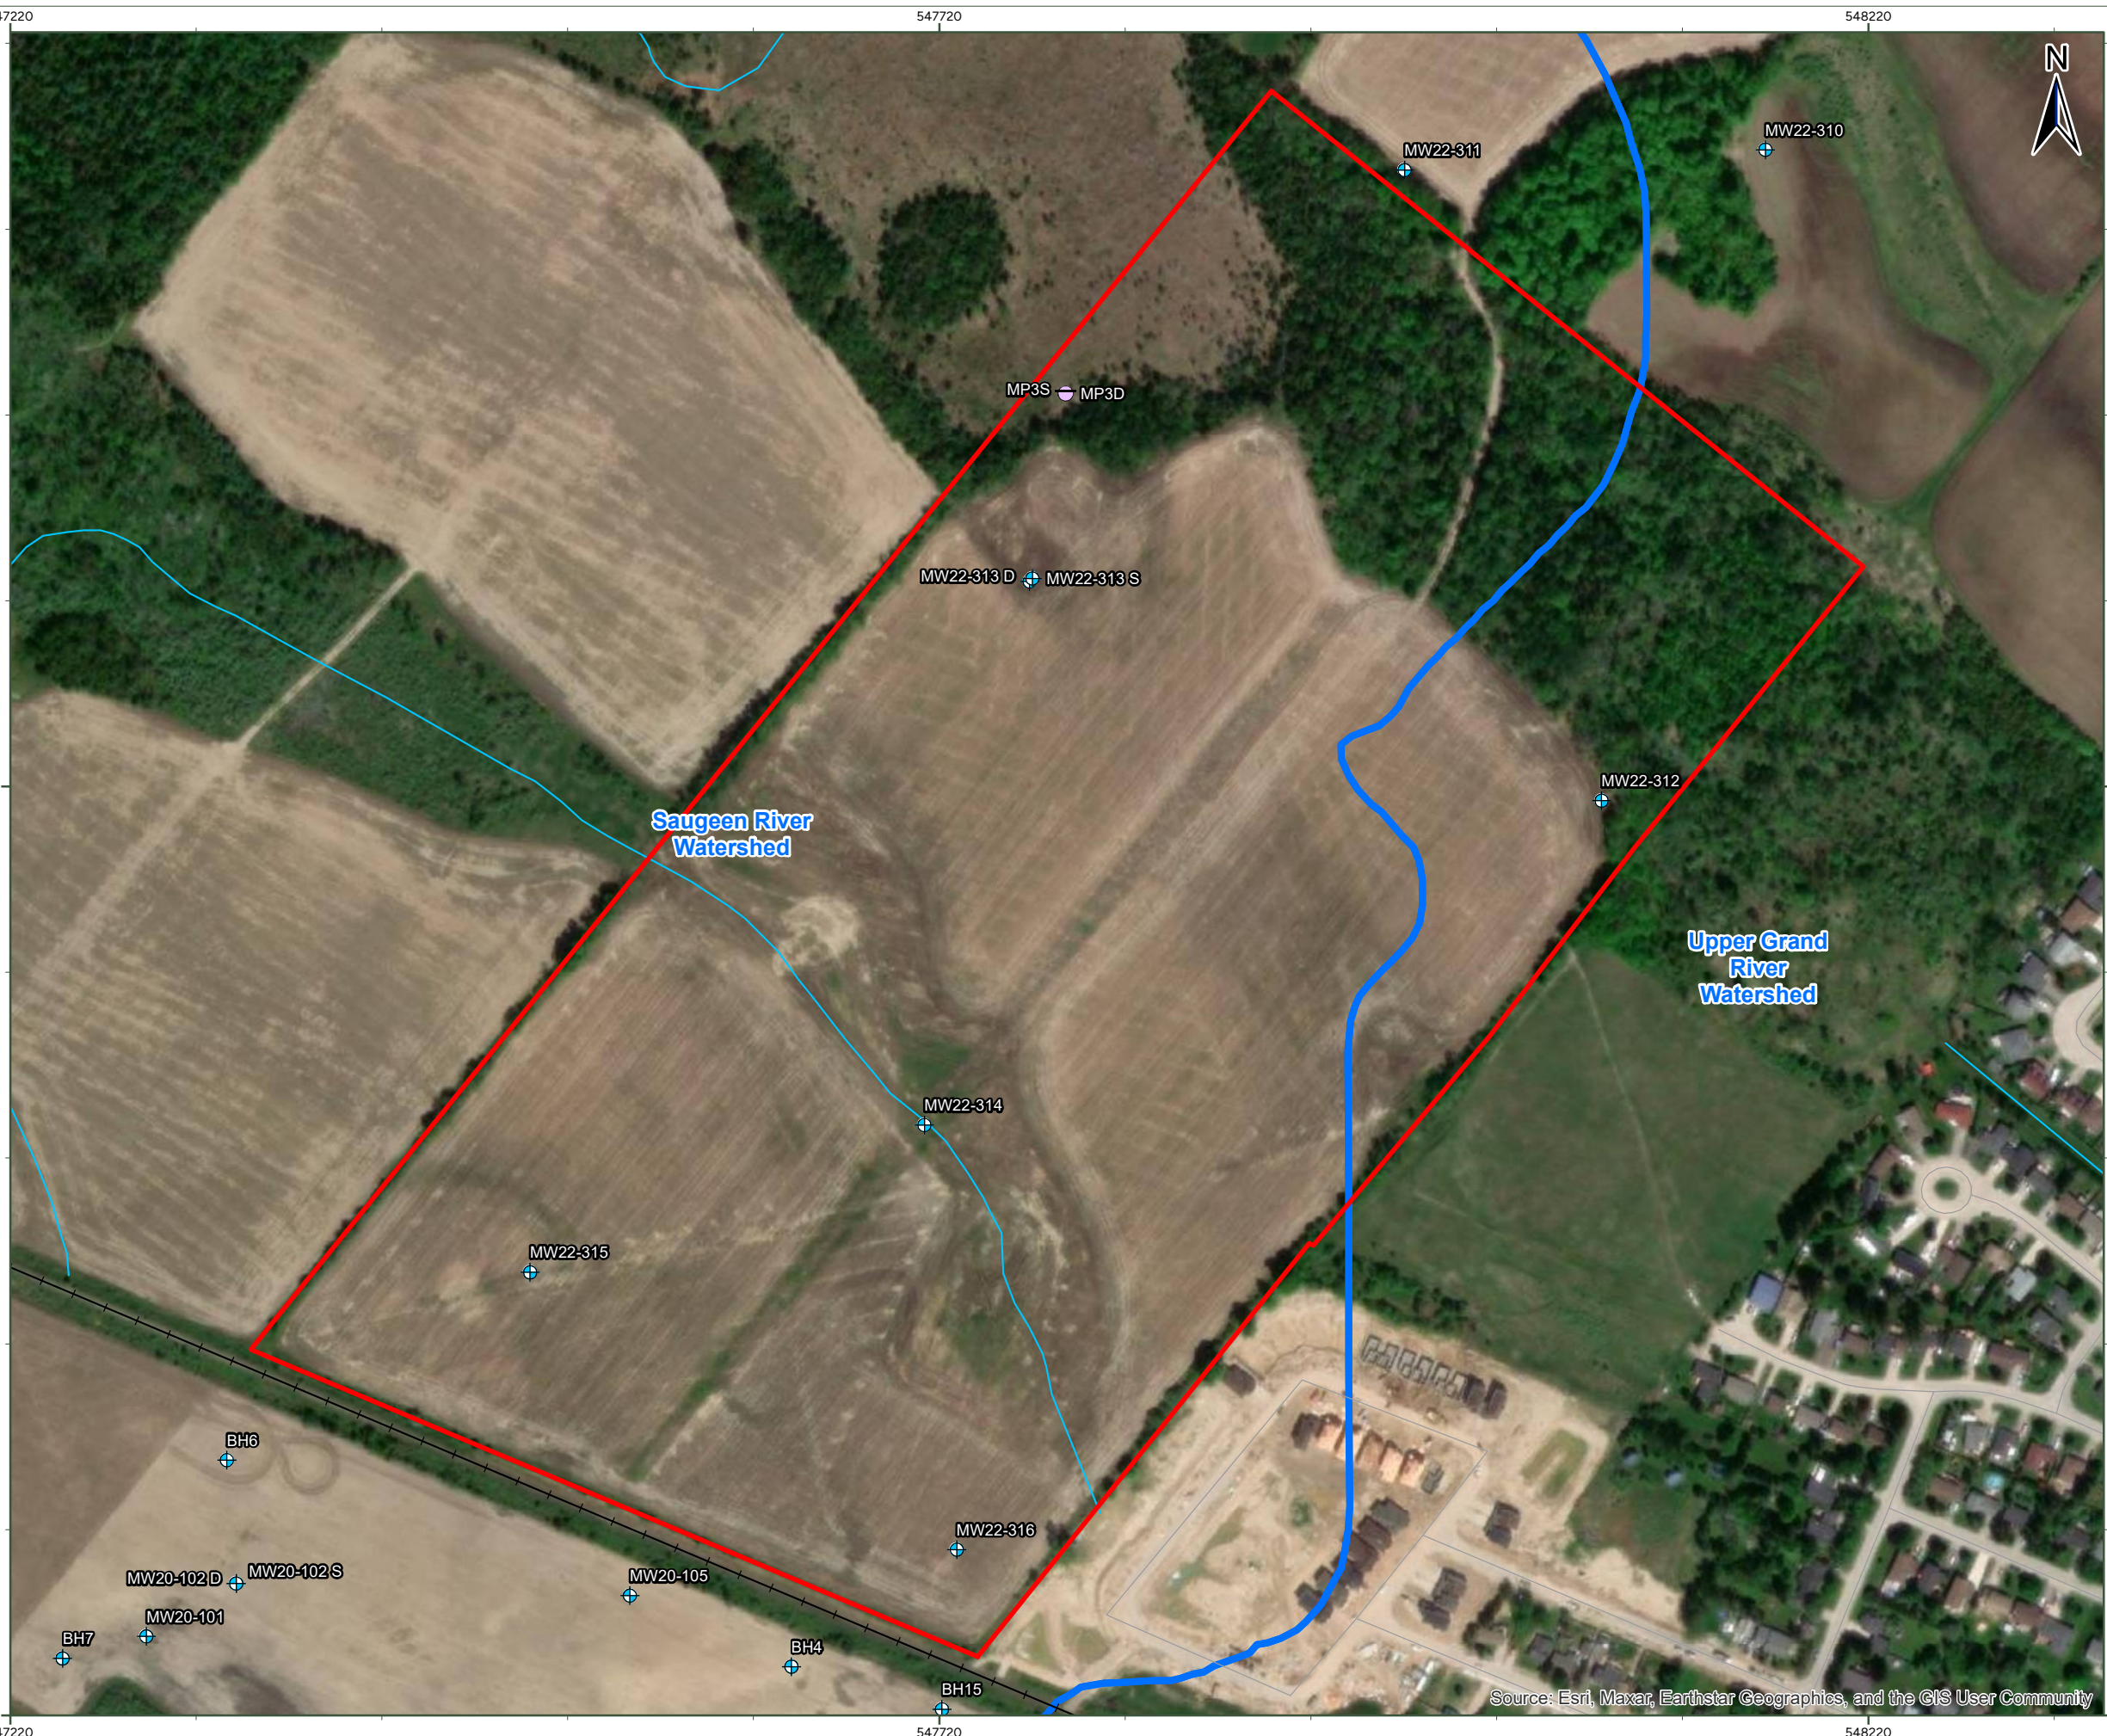
- SITE BOUNDARY
- MONITORING WELL
- MINI-PIEZOMETER
- PERMANENT WATERCOURSE
- DRAINAGE DIVIDE

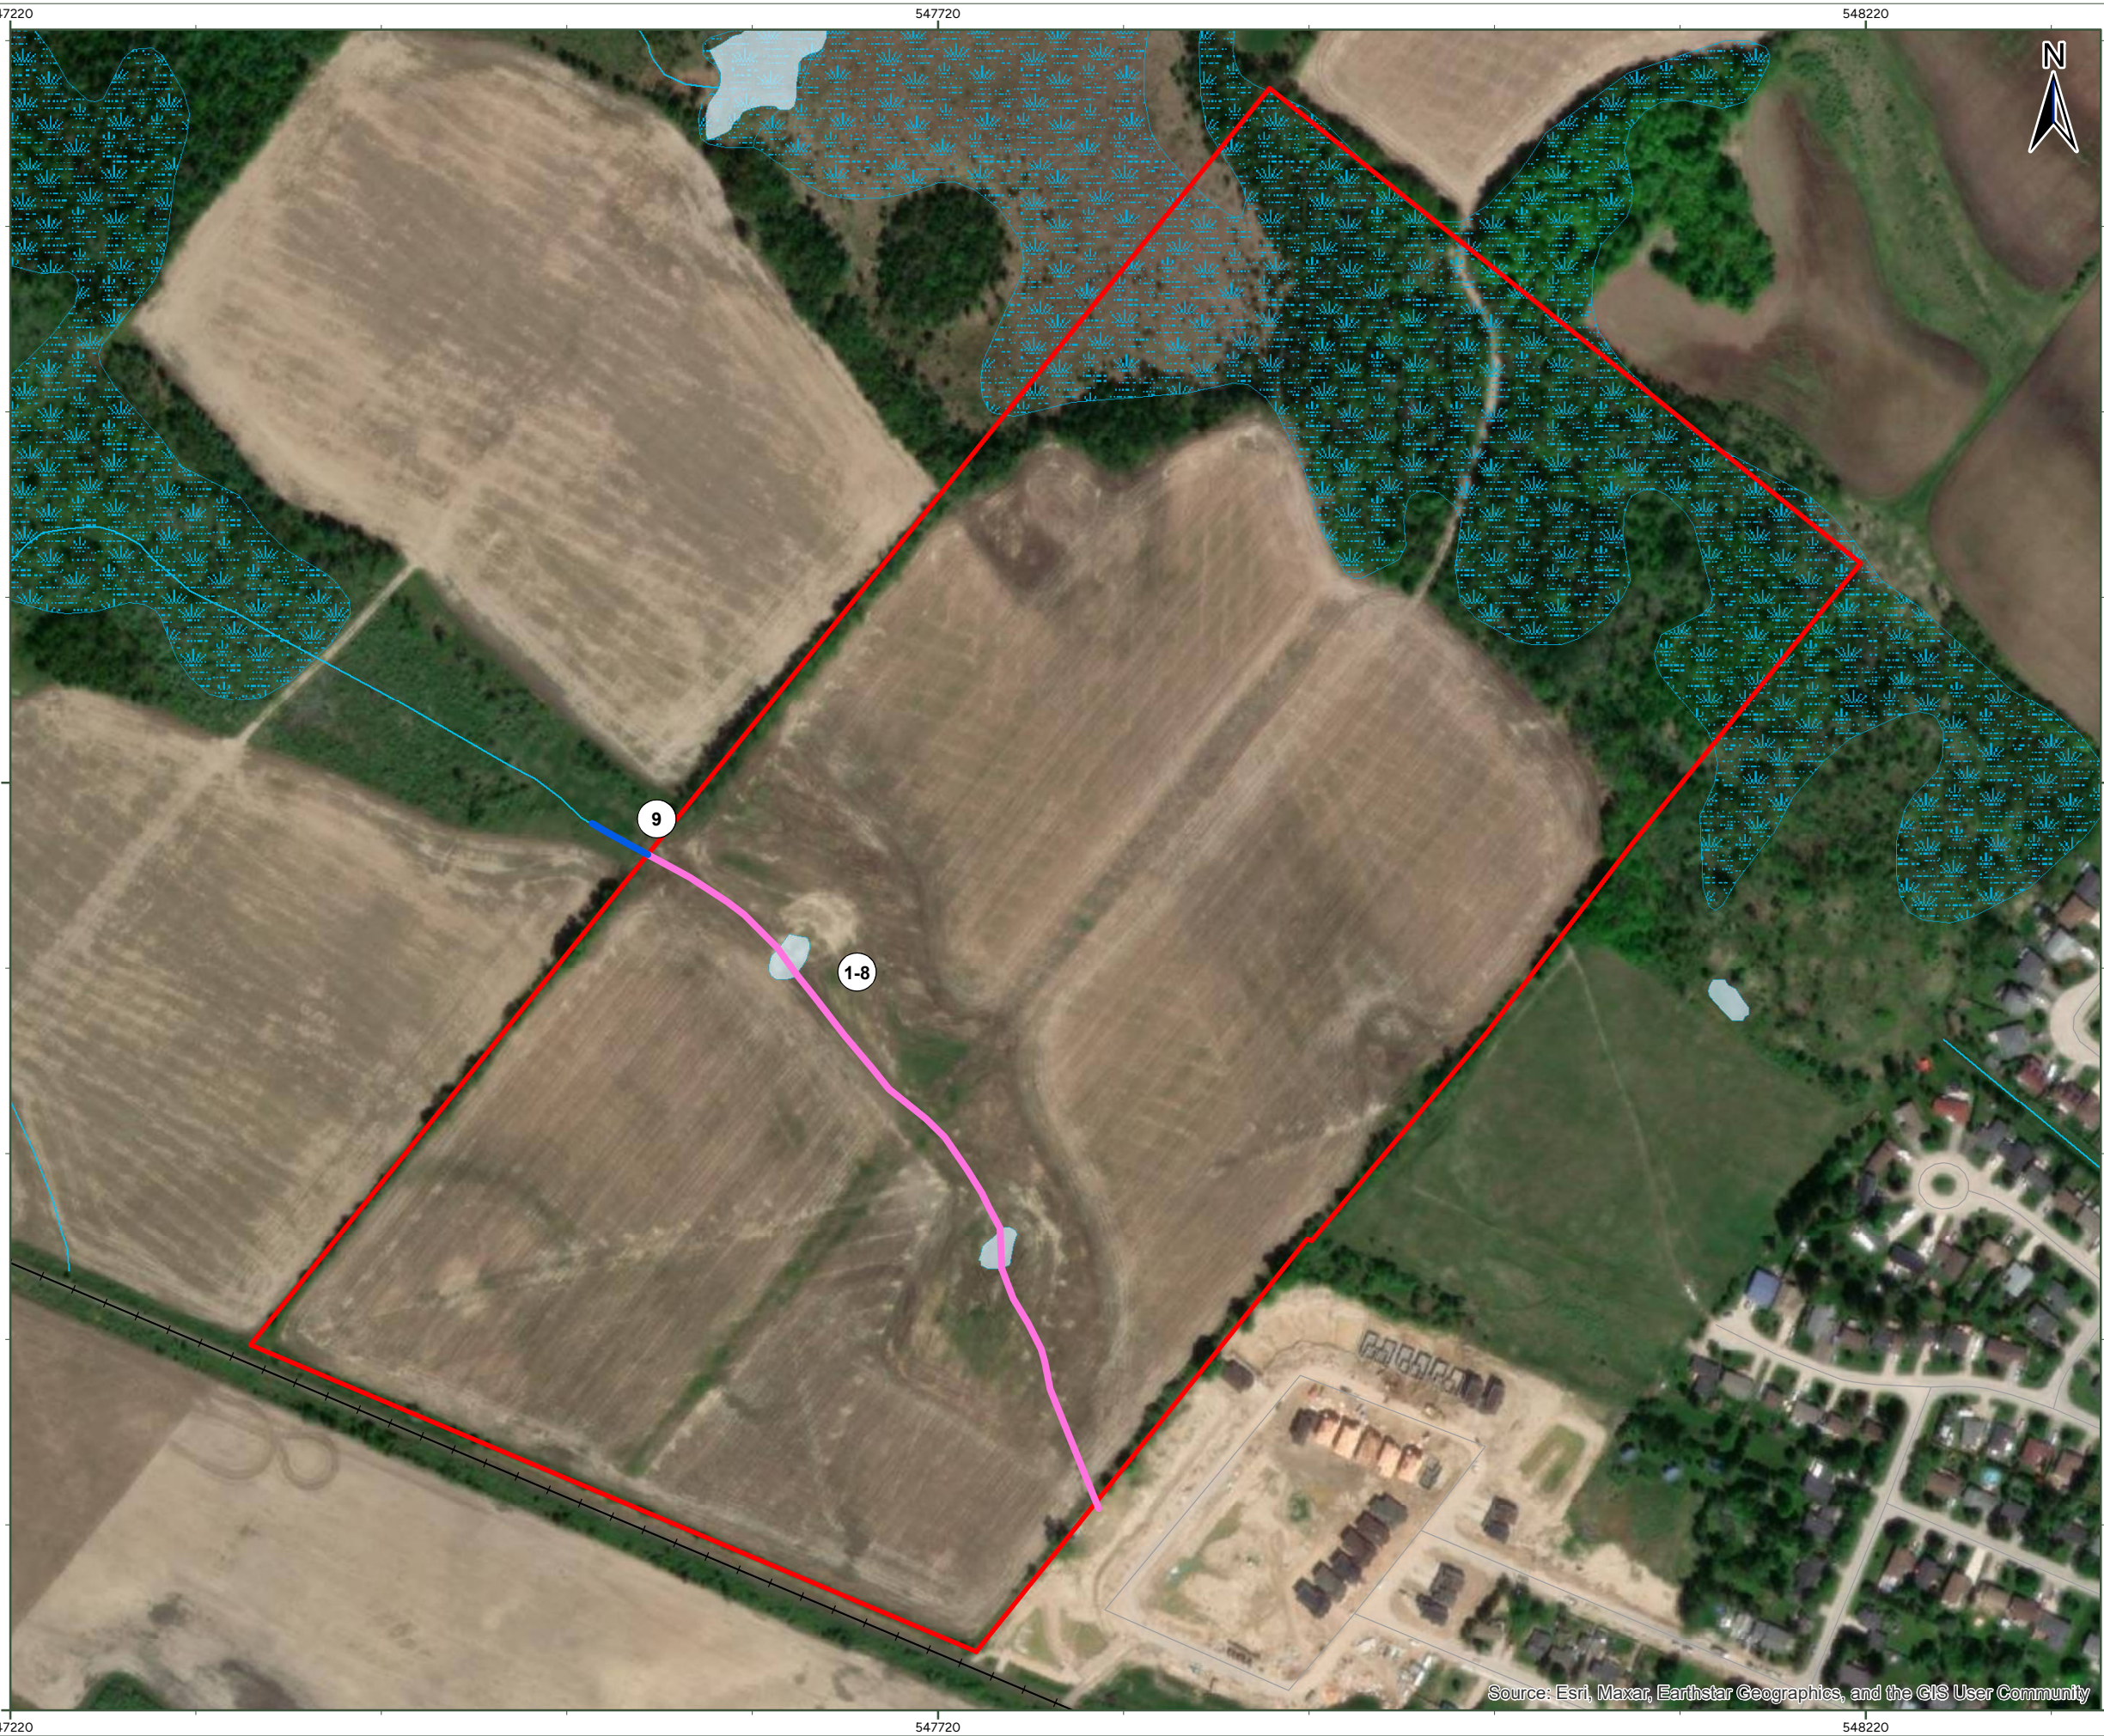
FIGURE NO:
3

- SITE BOUNDARY
- OBSERVATION LOCATION

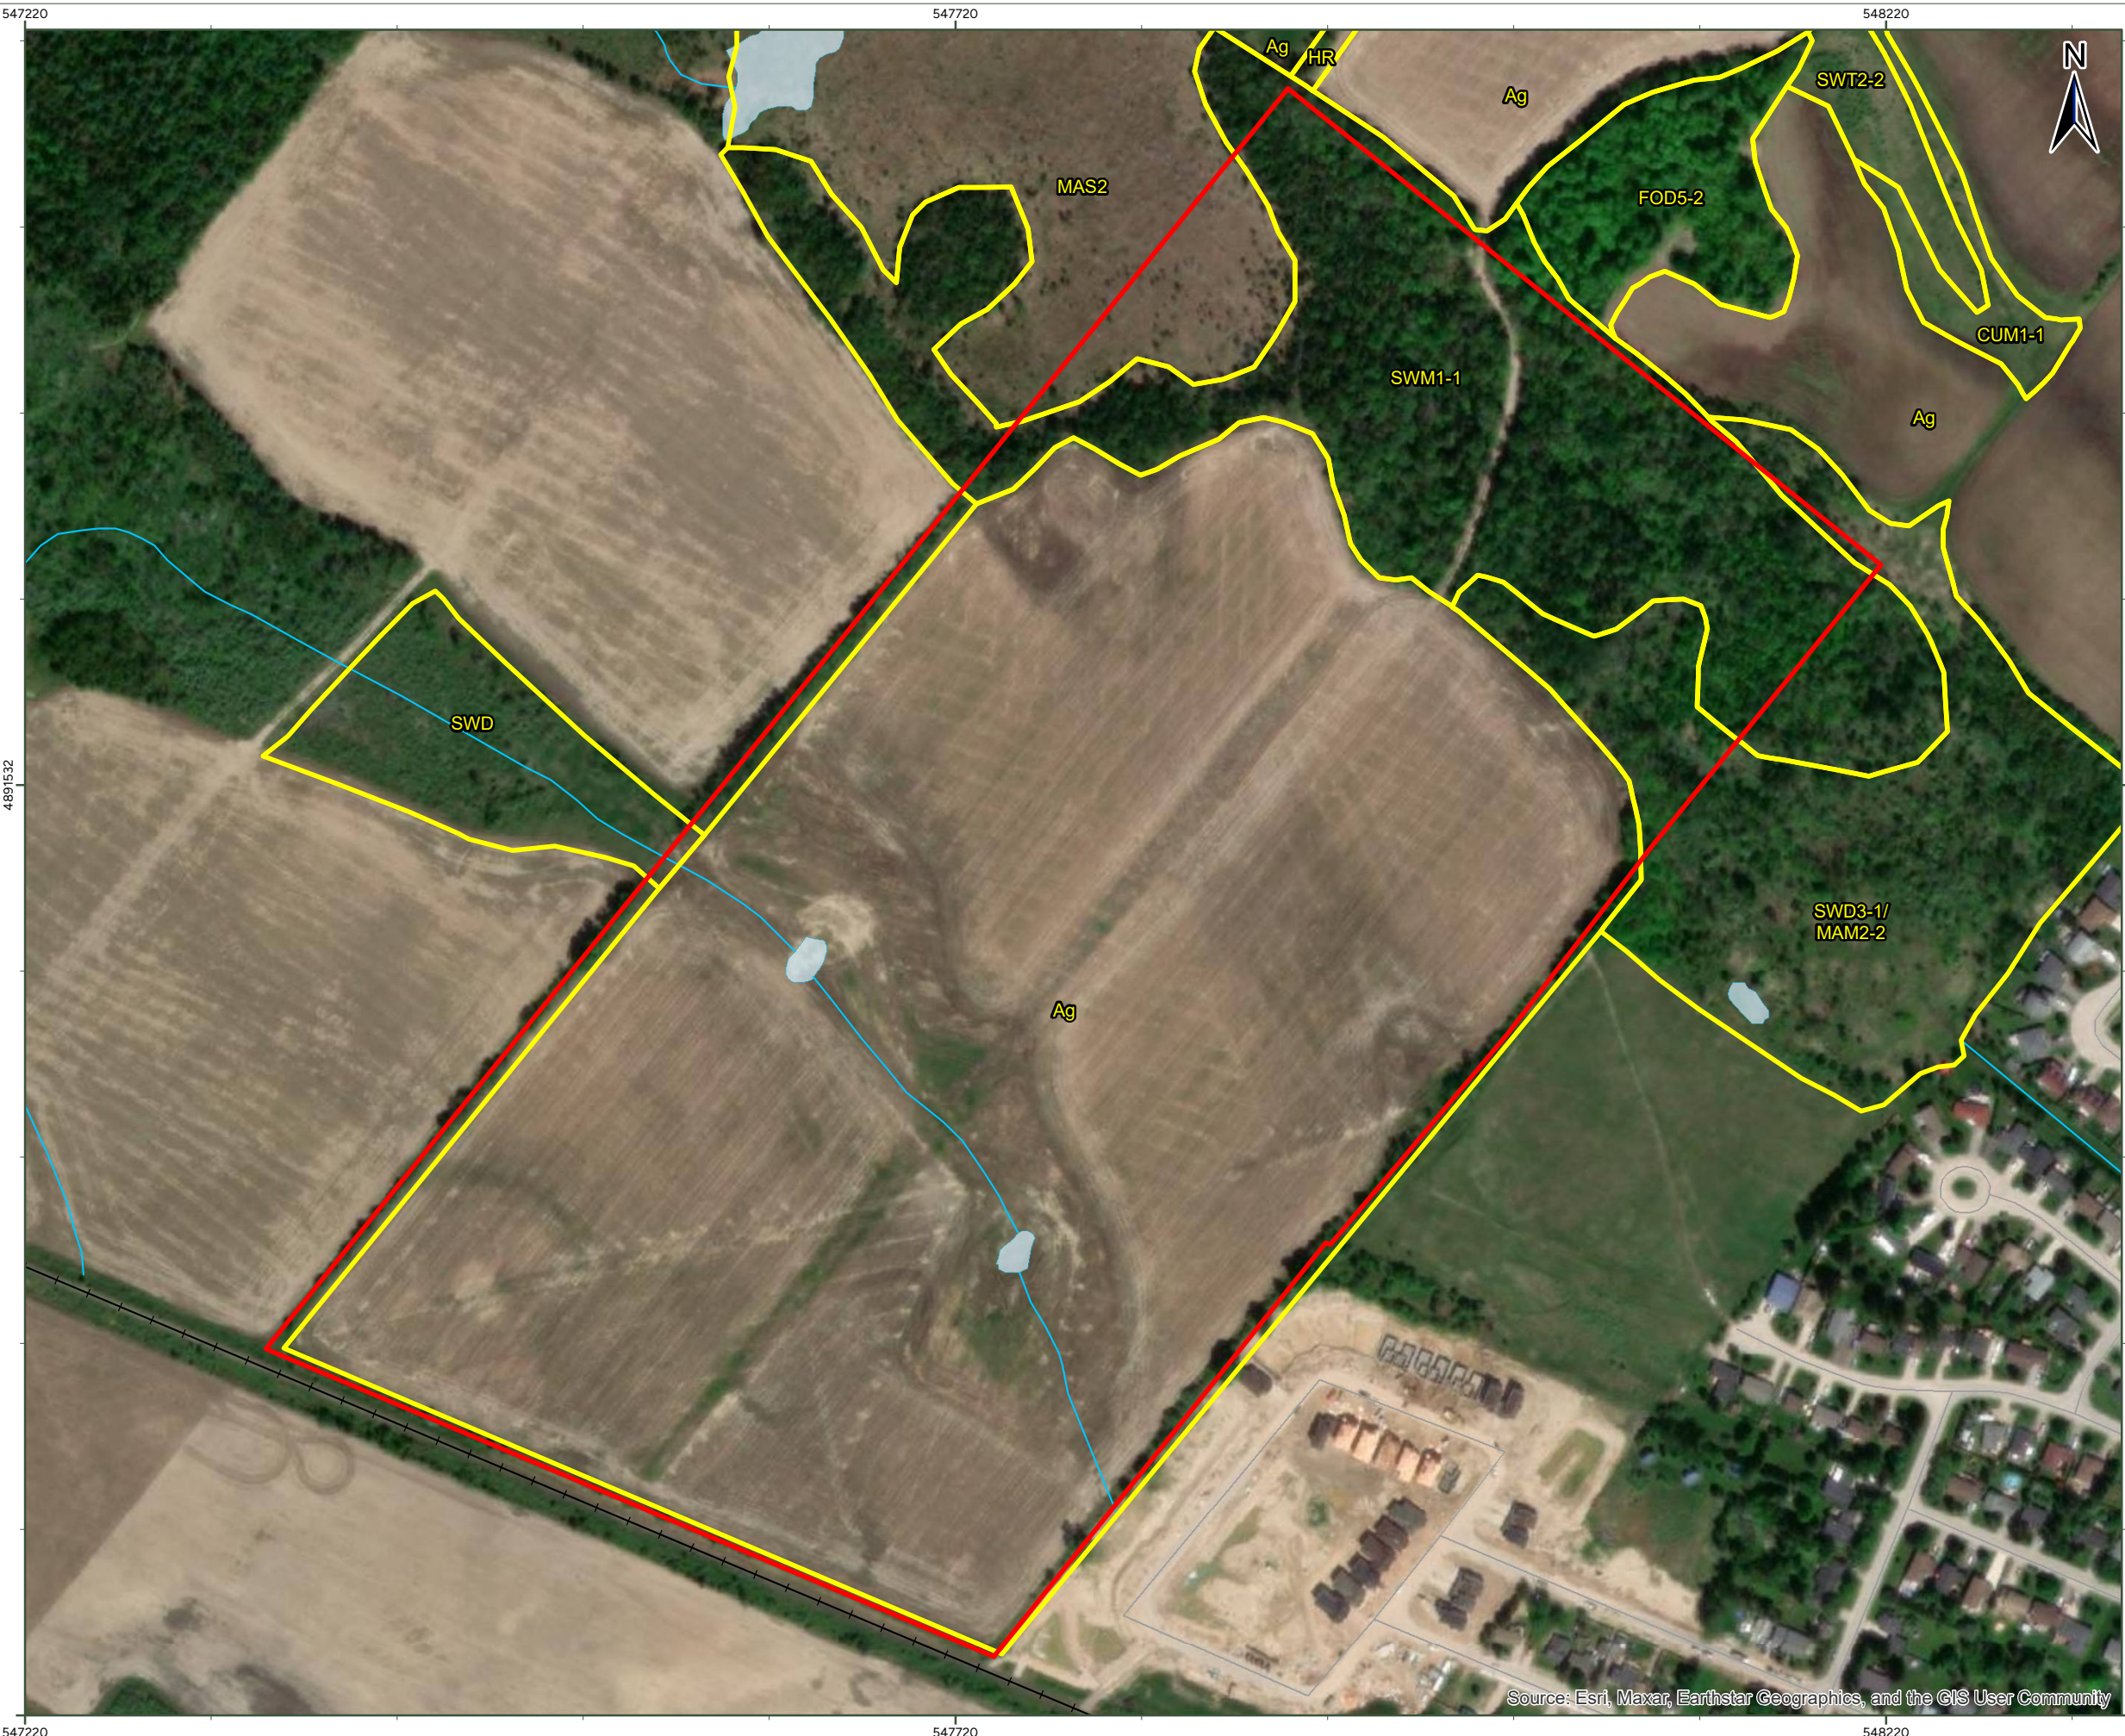
SLR FIGURE NO:
4

- SITE BOUNDARY
- ECOLOGICAL LAND CLASSIFICATION (SLR CONSULTING, 2022)
- WATERBODIES
- PERMANENT WATERCOURSE
- RAILWAY

ECOLOGICAL LAND CLASSIFICATION

Preliminary mapping of the vegetation communities is provided on (Figure 4) classified using Ecological Land Classification (ELC) (Lee et al., 1998). Each unit is named according to the soil and plant attributes and a code is assigned (e.g. Cultural Woodland, CUW). Wetland is delineated by the survey limit staked in the field as determined by the dominance of wetland vegetation and hydric soils. The site is largely agricultural, and wetland and woodland forest communities separate the eastern and western portions. Wetland communities contiguous with those on the site extend north and south of the site. Wetland associated with a watercourse on site occurs in the eastern portion of the site, immediately southwest of Highway 10 along with a farmhouse and associated outbuildings and landscape trees. Deciduous hedgerows occur along some field and site boundaries A botanical inventory is provided in Appendix B.

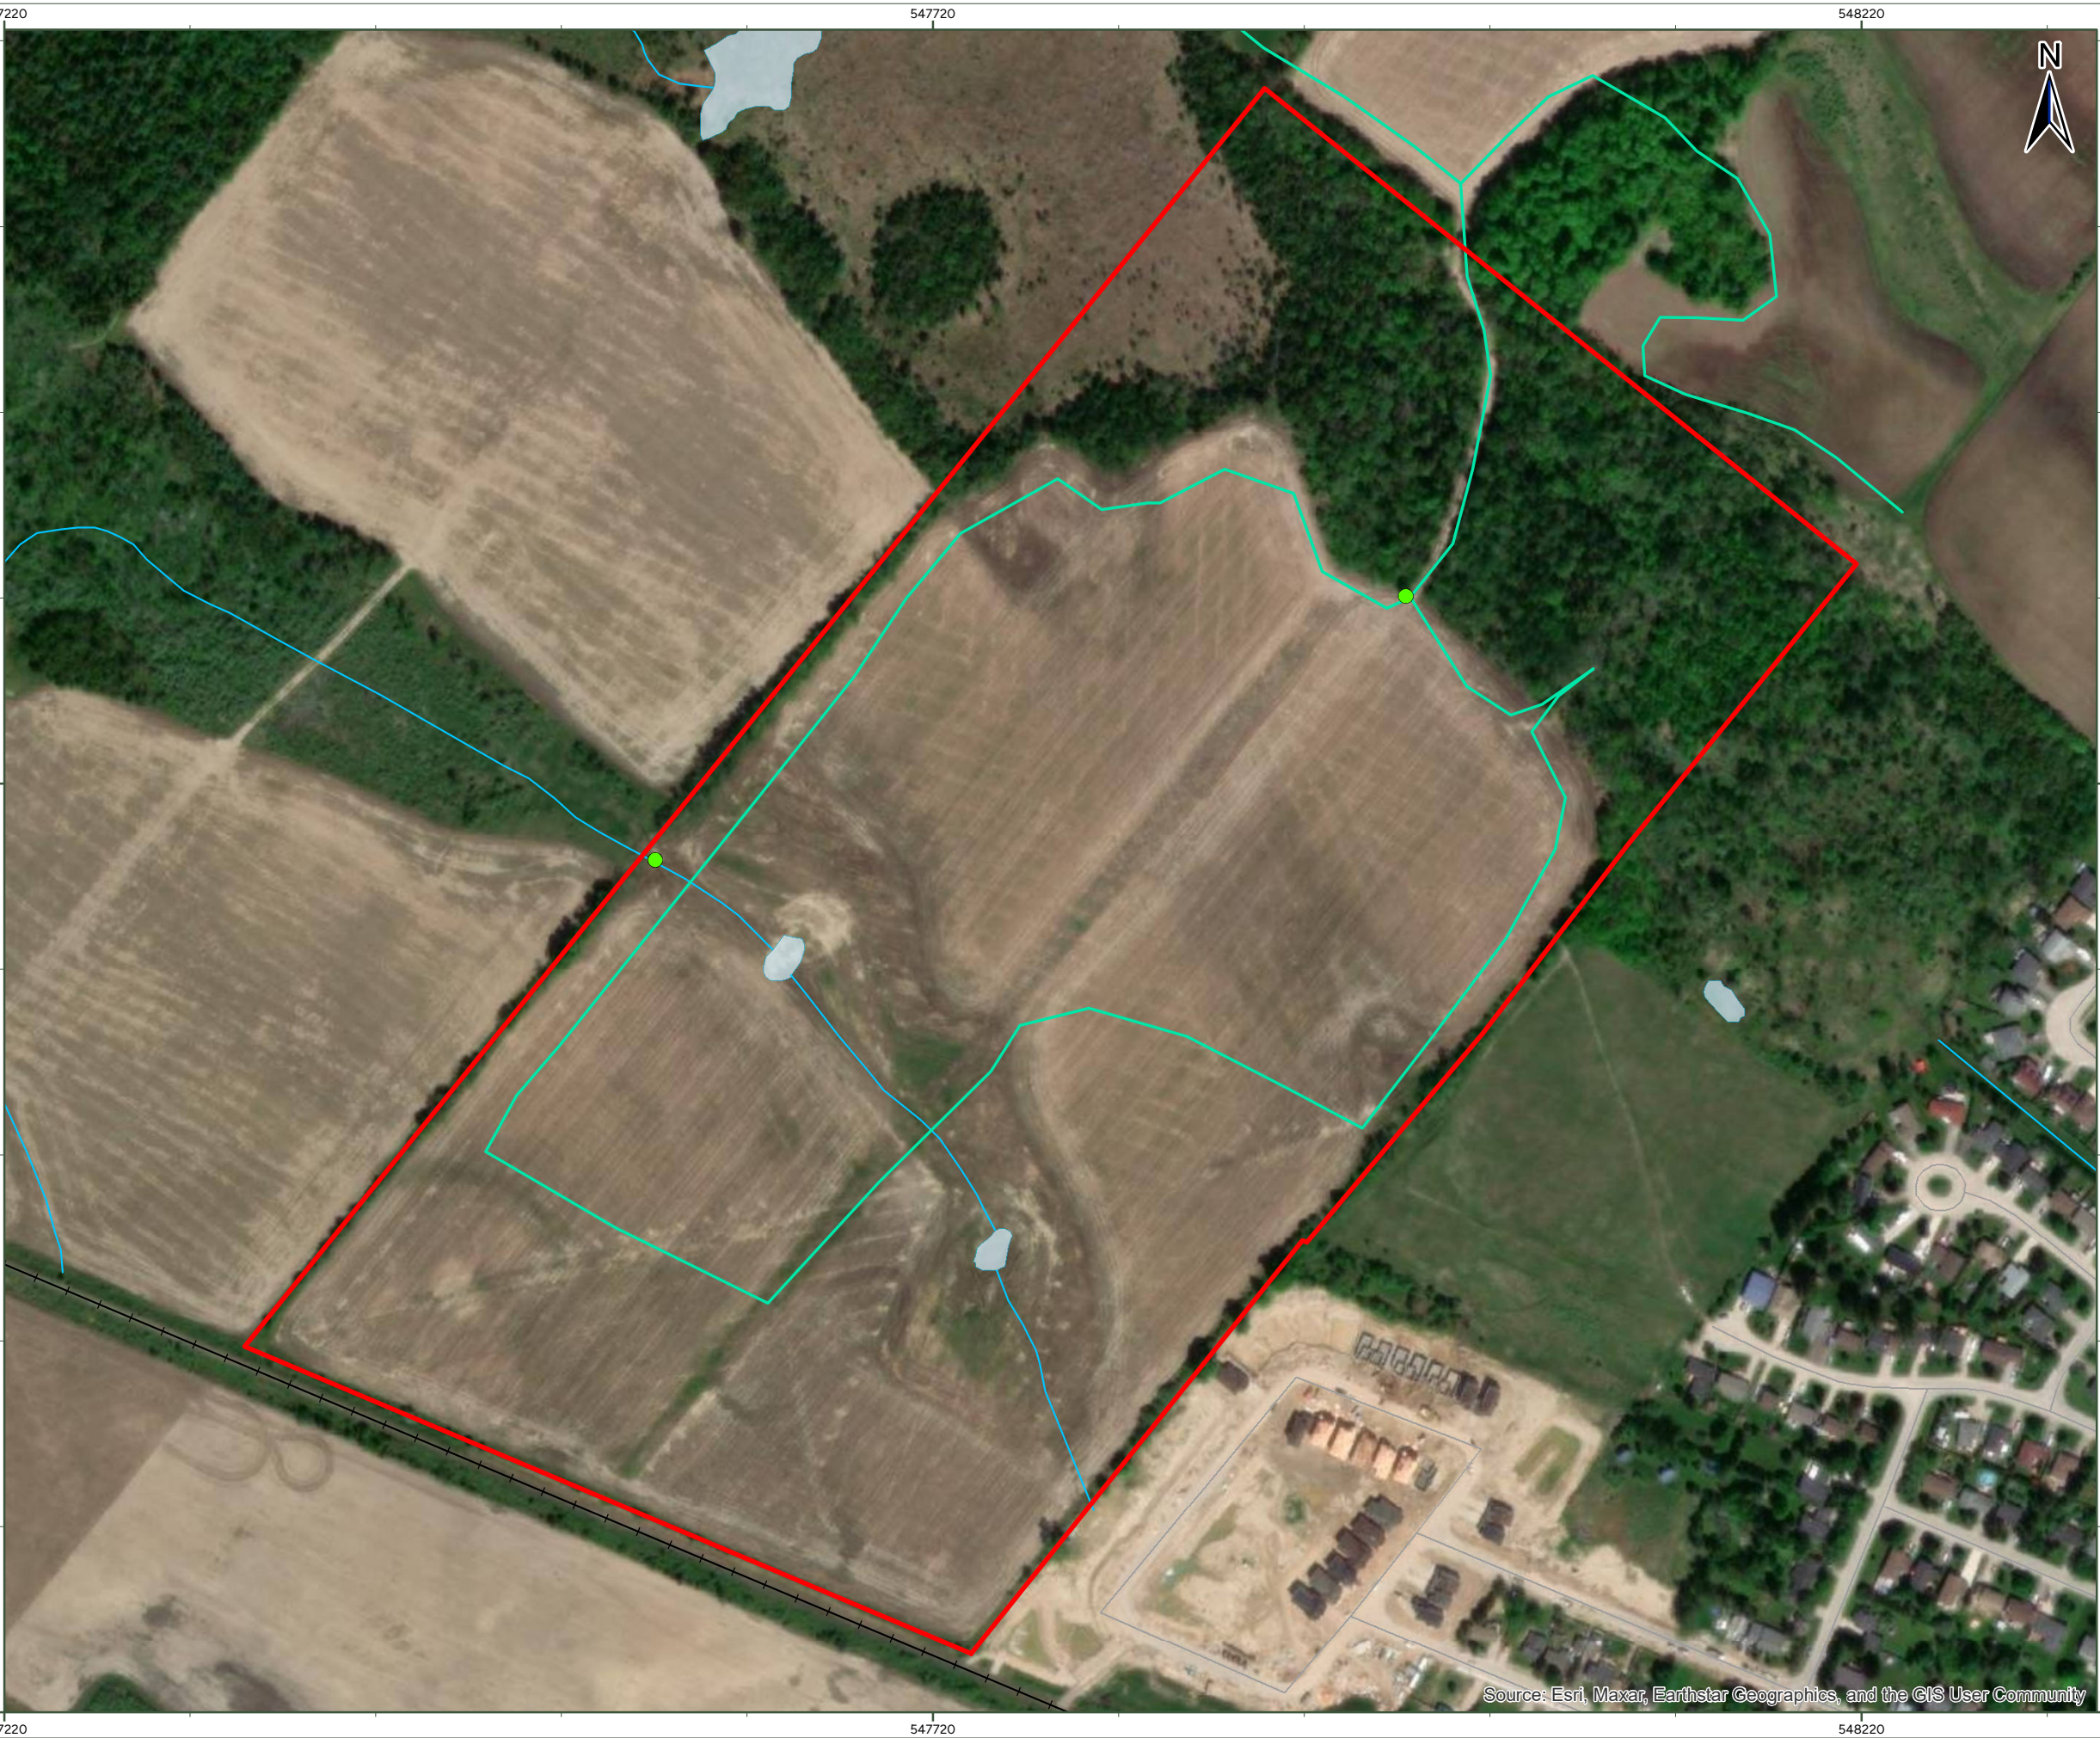
SLR FIGURE NO:
5

- SITE BOUNDARY
- AMPHIBIAN SURVEY LOCATION (2022)
- BREEDING BIRD SURVEY (TRANSECT; 2022)
- WATERBODIES
- PERMANENT WATERCOURSE
- RAILWAY

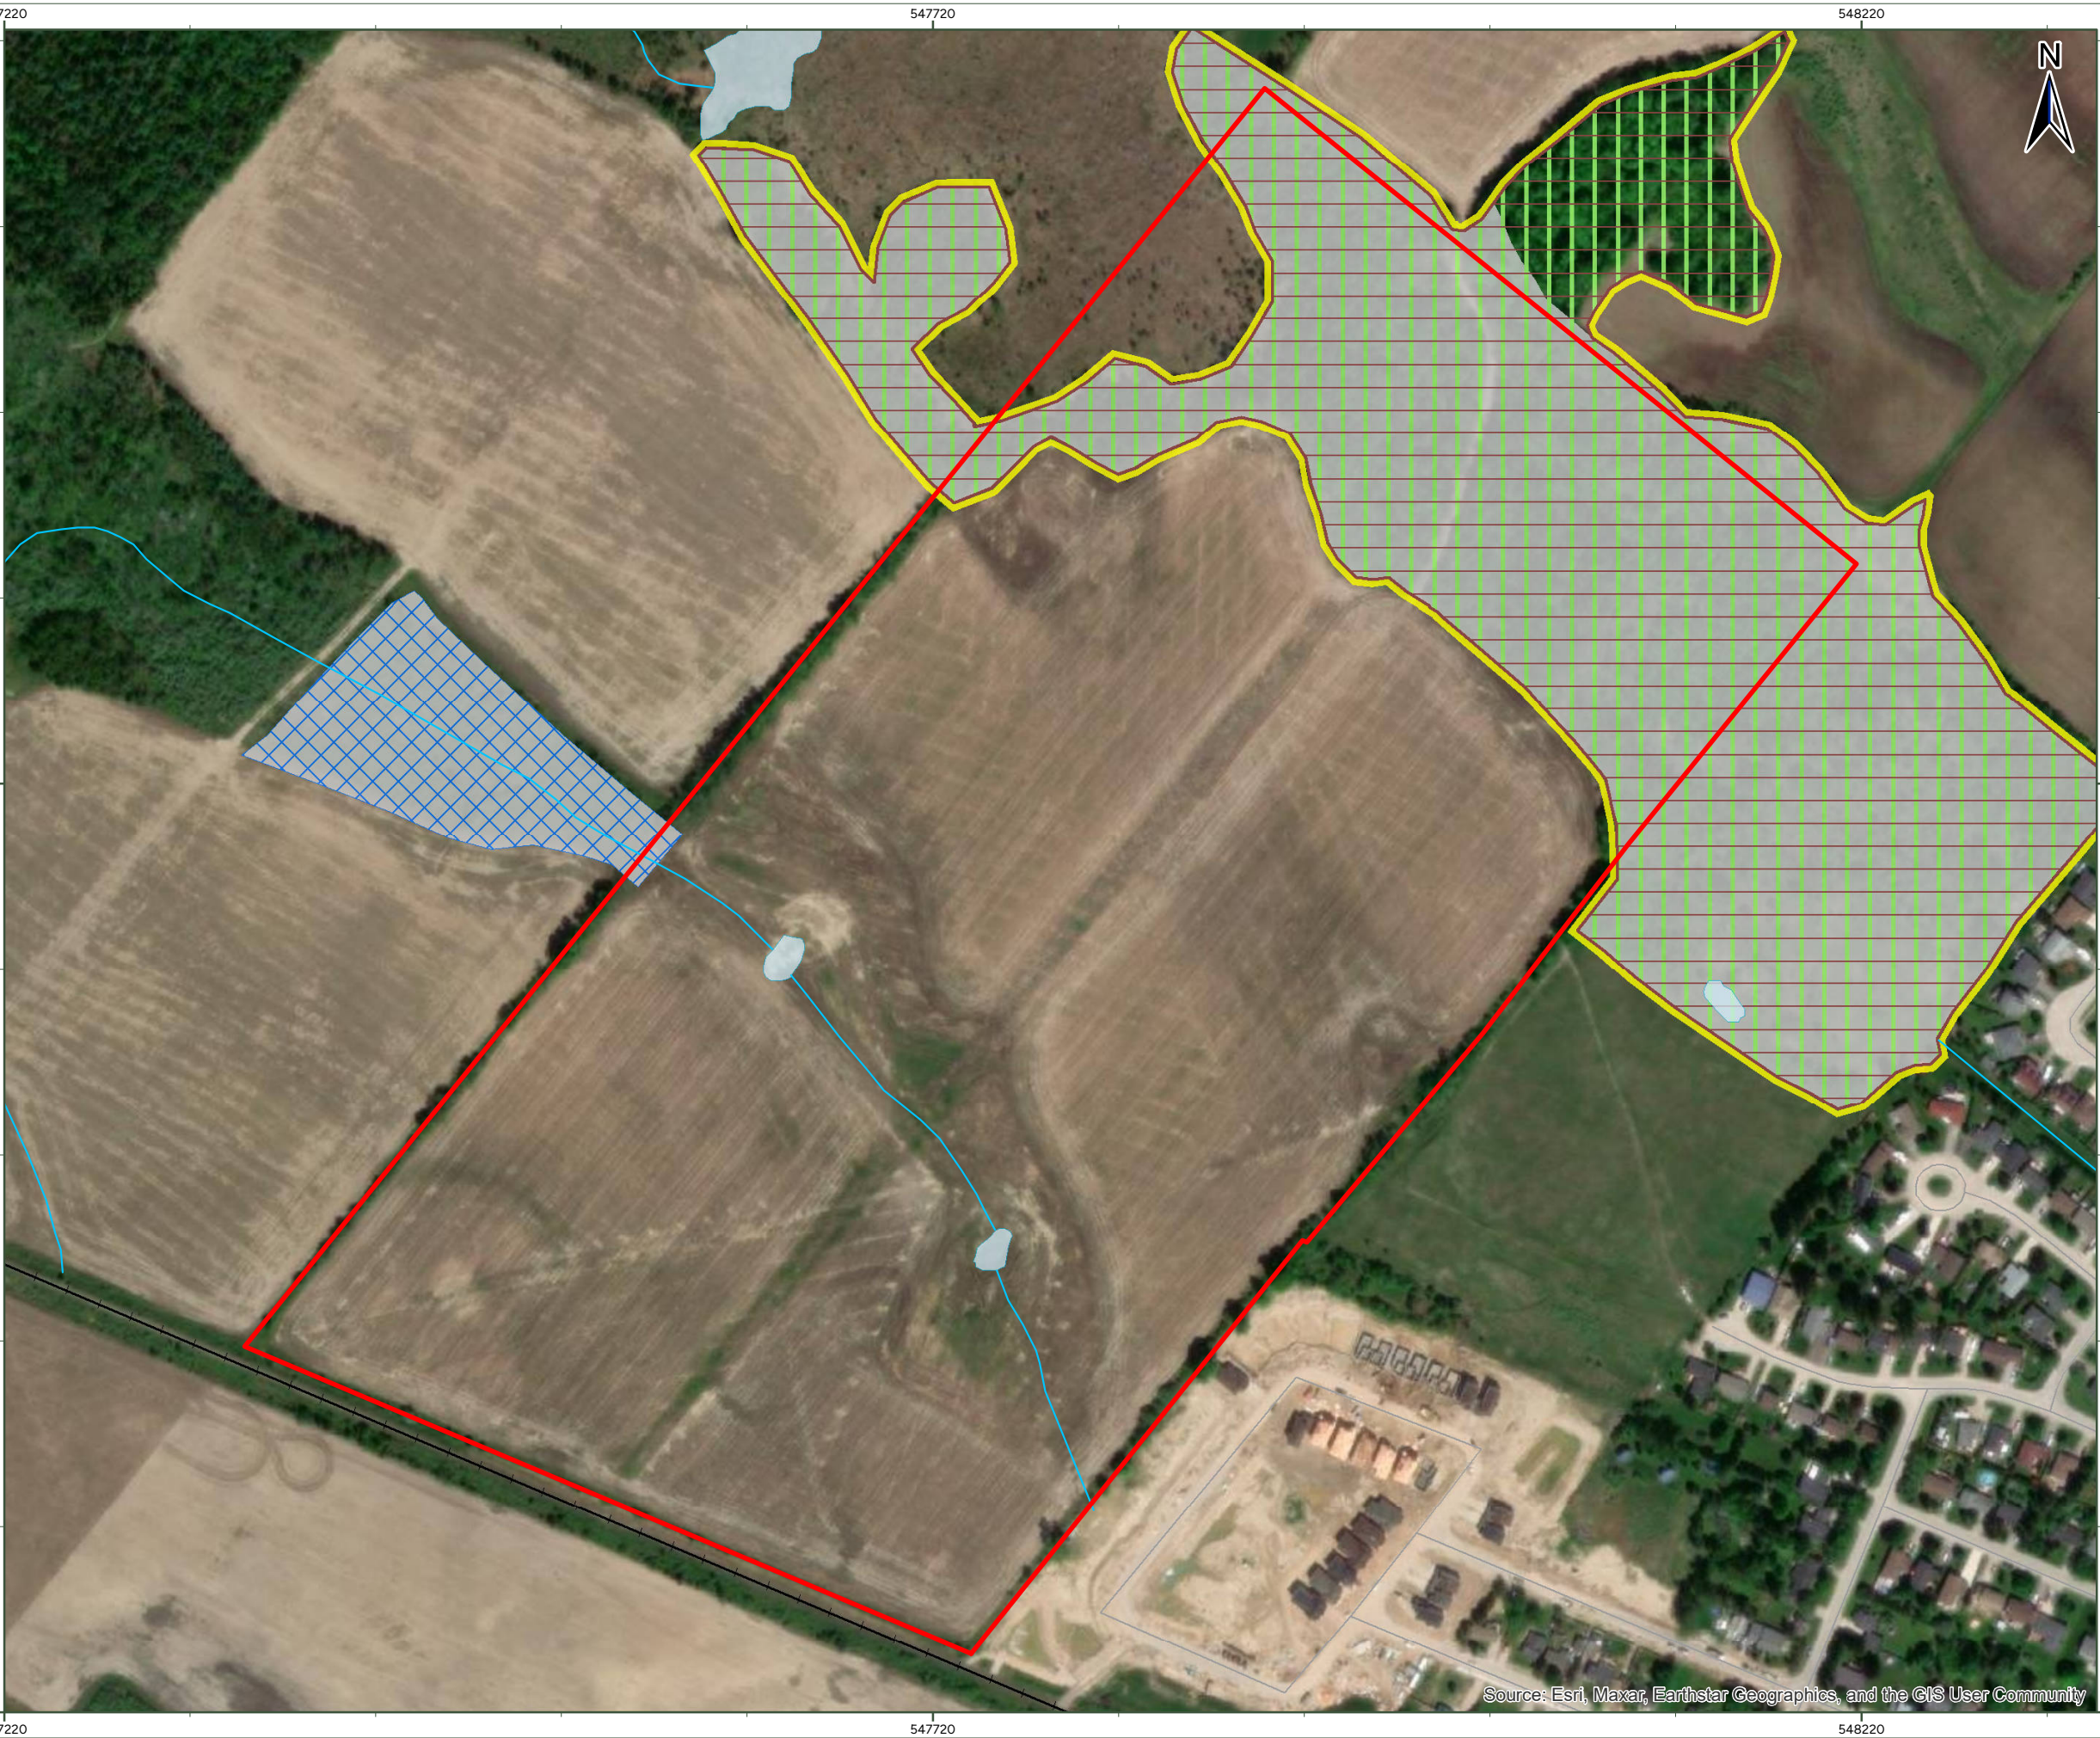
- SITE BOUNDARY
- CONFIRMED SWH**
- AMPHIBIAN BREEDING HABITAT (WETLANDS)
- EASTERN WOOD-PEWEE
- TERRESTRIAL CRAYFISH
- WOODLAND AREA - SENSITIVE BIRD BREEDING HABITAT
- CANDIDATE SWH**
- BAT MATERNITY COLONIES
- WATERBODIES
- PERMANENT WATERCOURSE
- RAILWAY
