Environmental Impact Study

Glenelg Phase 3

Flato Developments Inc.

SLR Consulting (Canada) Ltd.

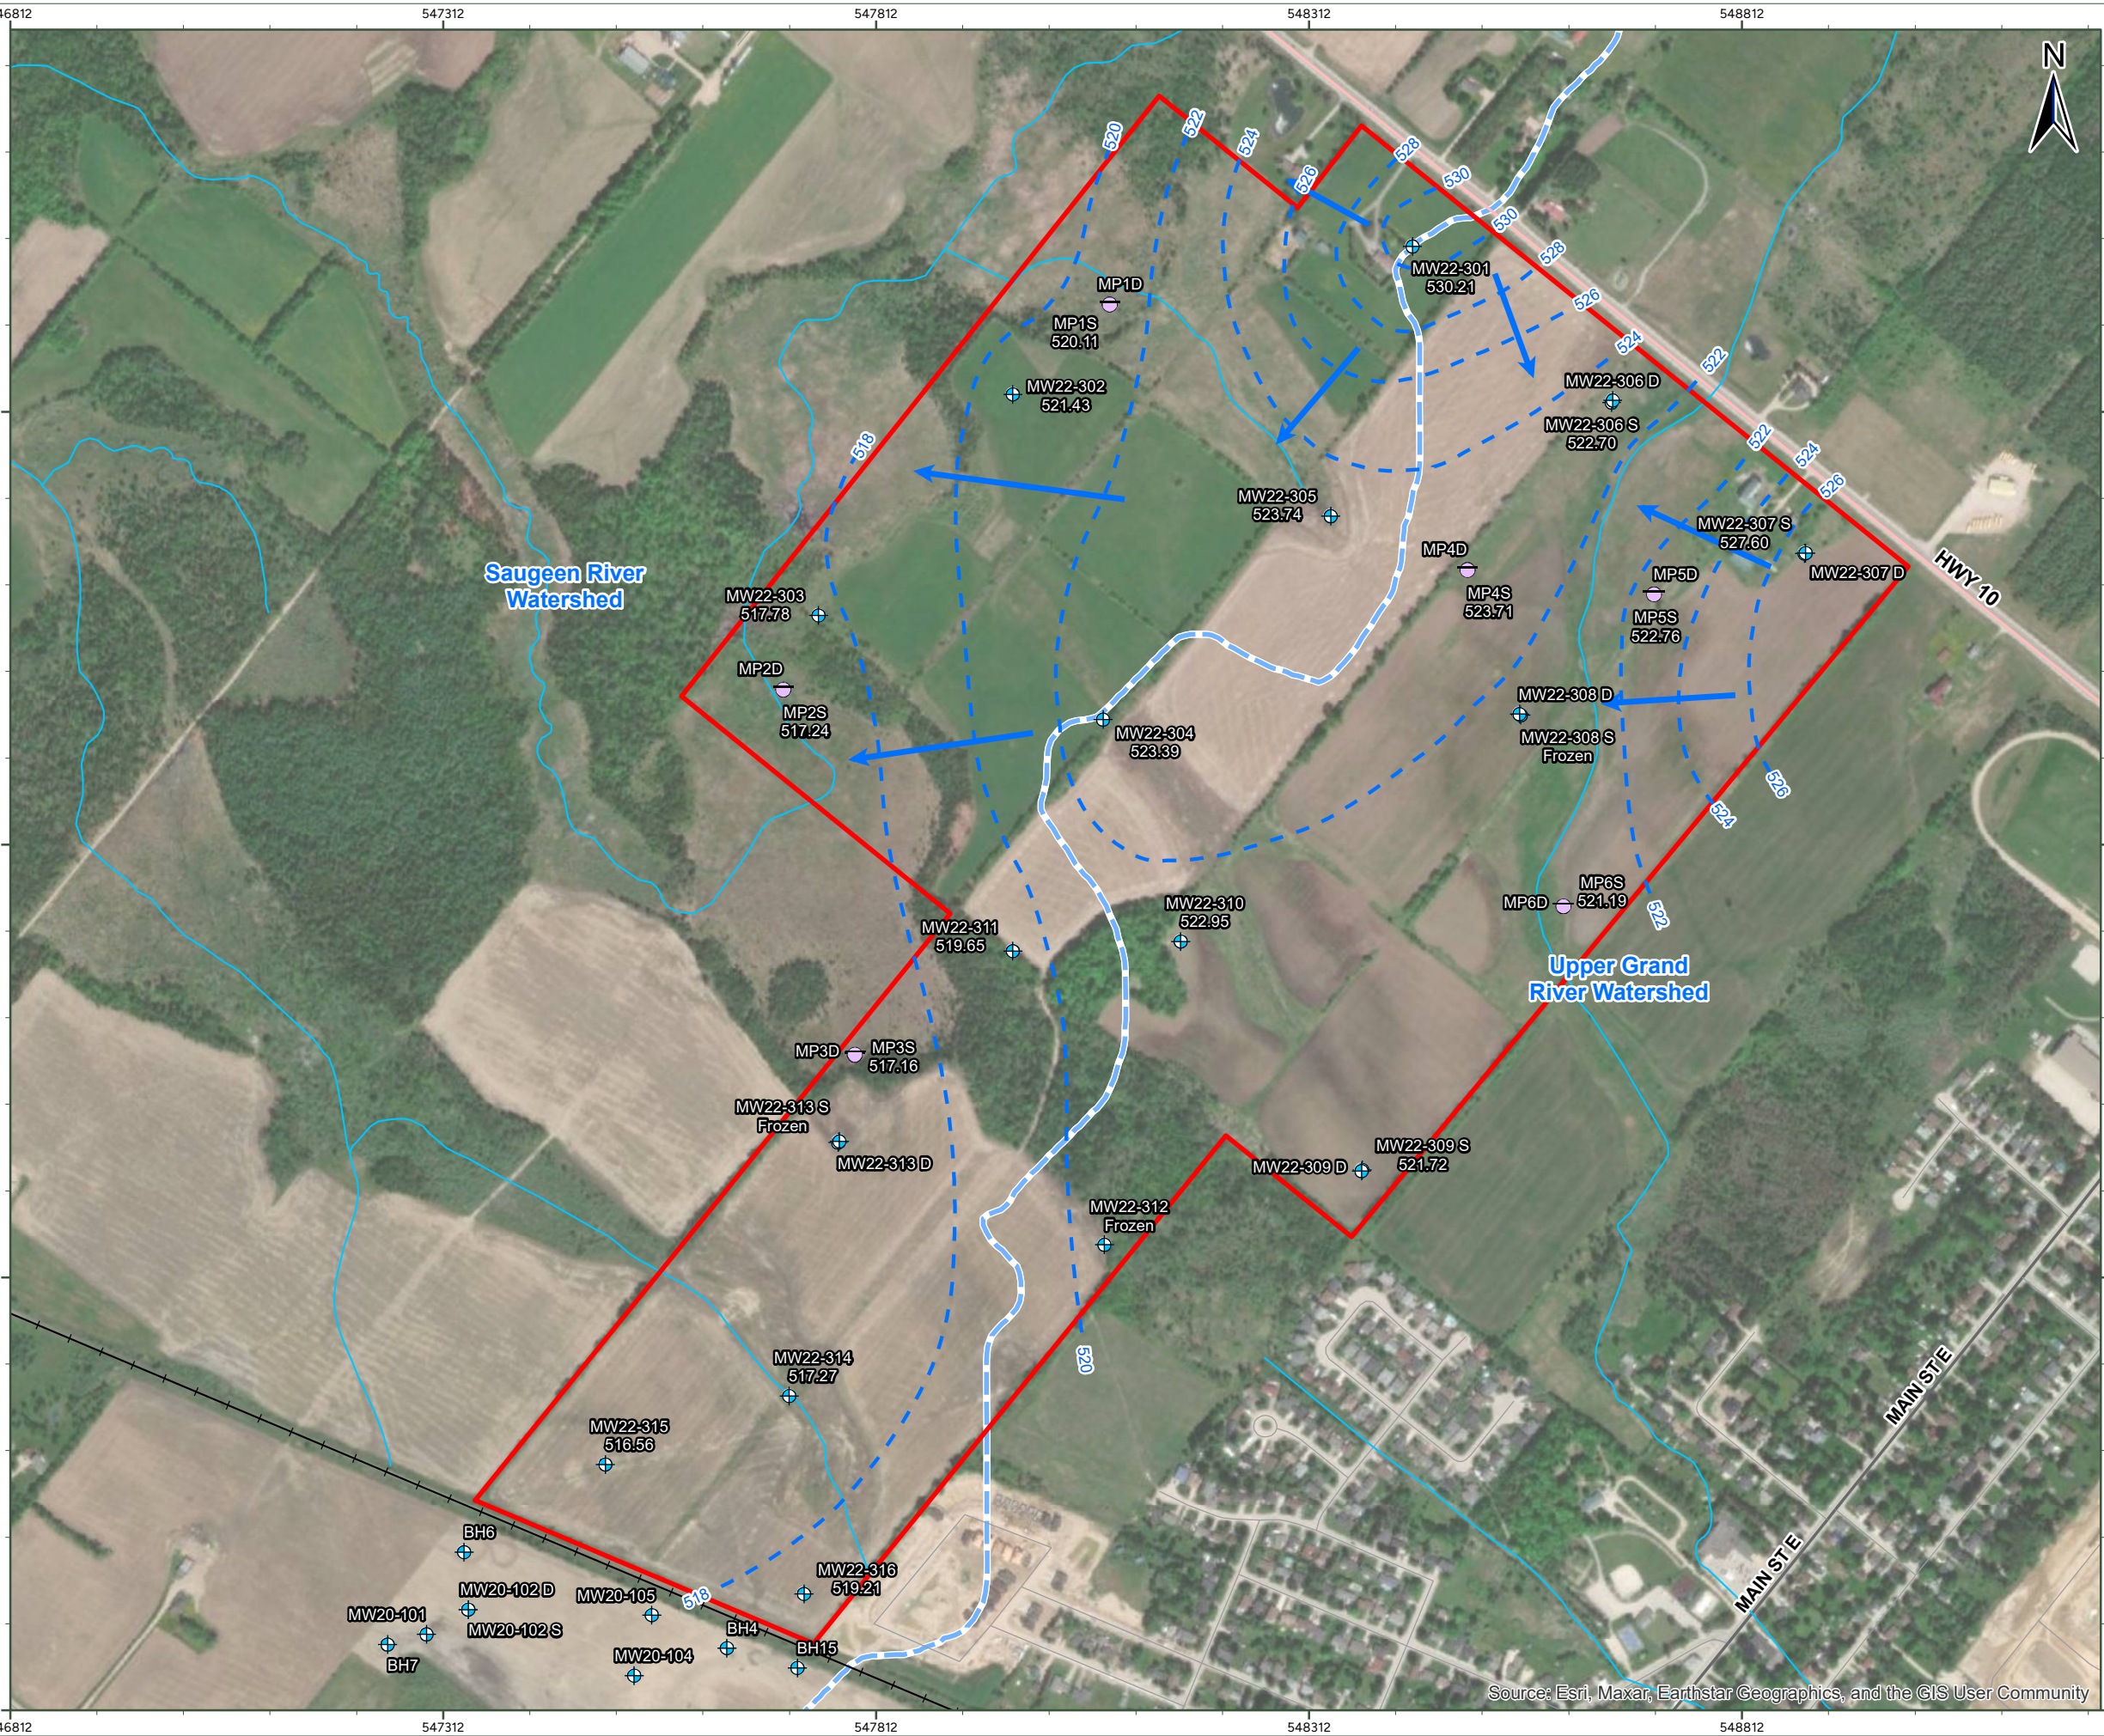
- SITE BOUNDARY
- + MONITORING WELL
- MINI-PIEZOMETER
- INFERRED GROUNDWATER ELEVATION CONTOUR
- INFERRED GROUNDWATER FLOW DIRECTION
- 519.1** GROUNDWATER ELEVATION (MARCH 28, 2023)
- PERMANENT WATERCOURSE
- DRAINAGE DIVIDE

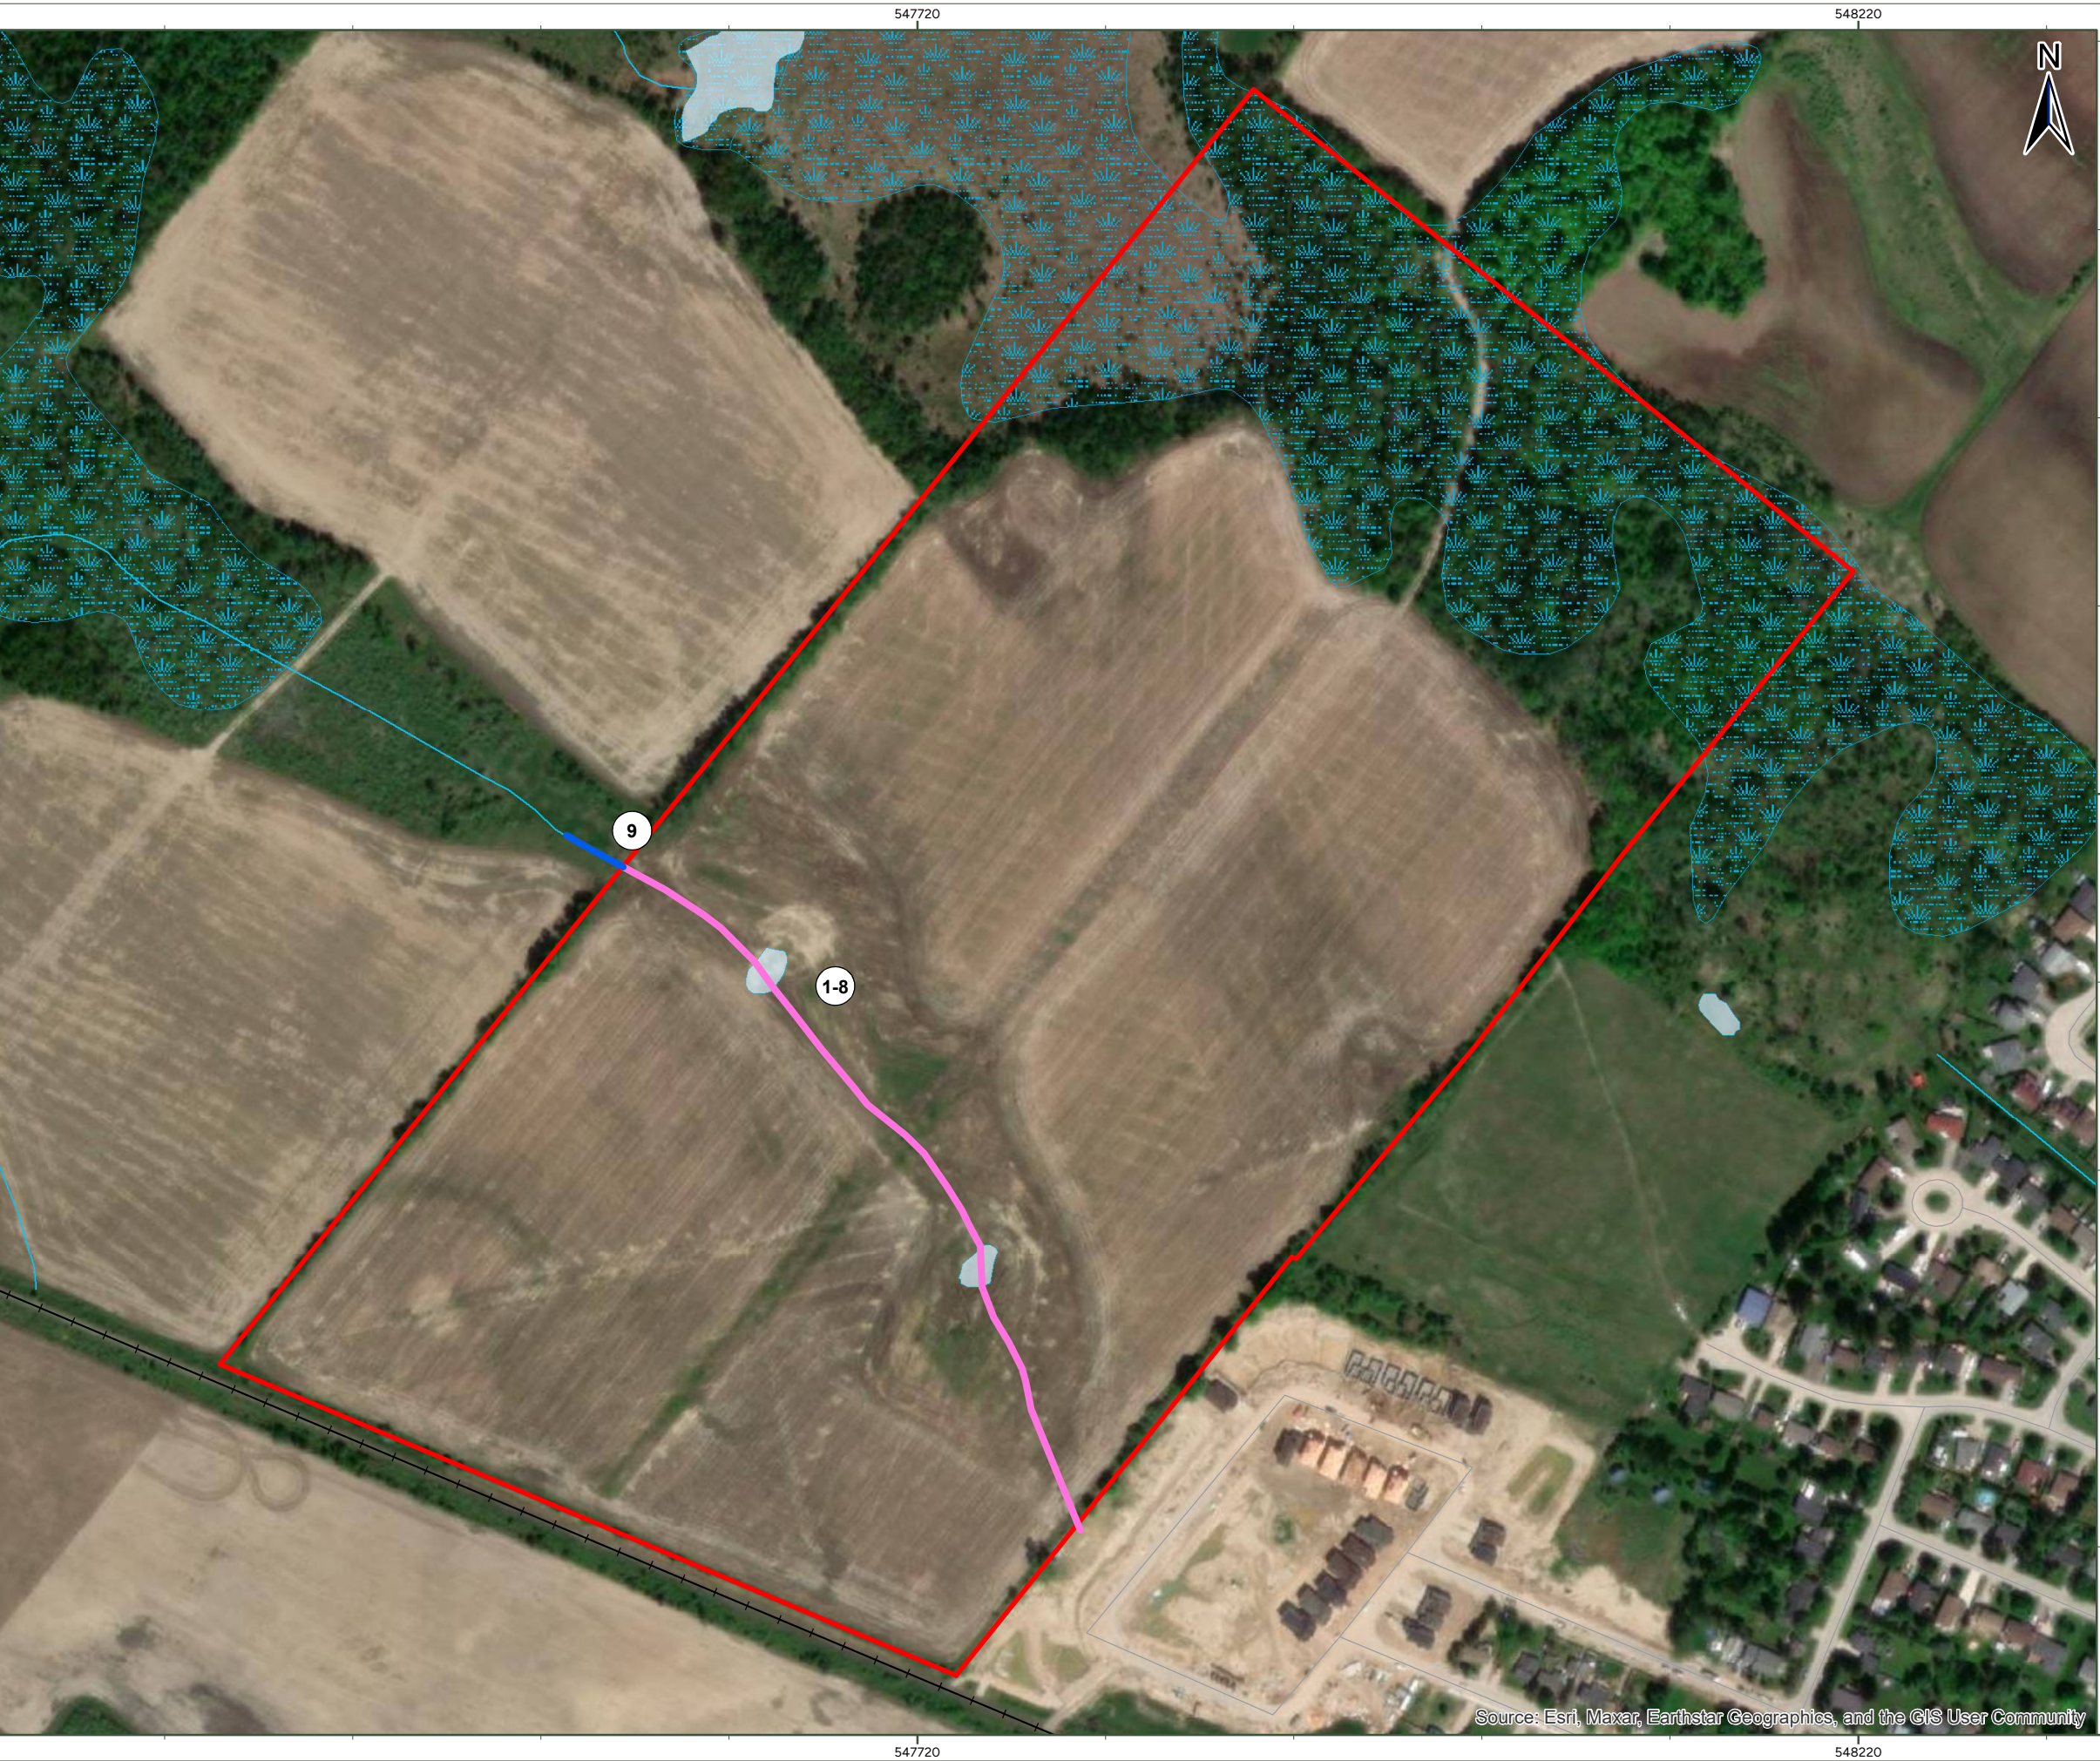
FIGURE NO:
2

- SITE BOUNDARY
- OBSERVATION LOCATION

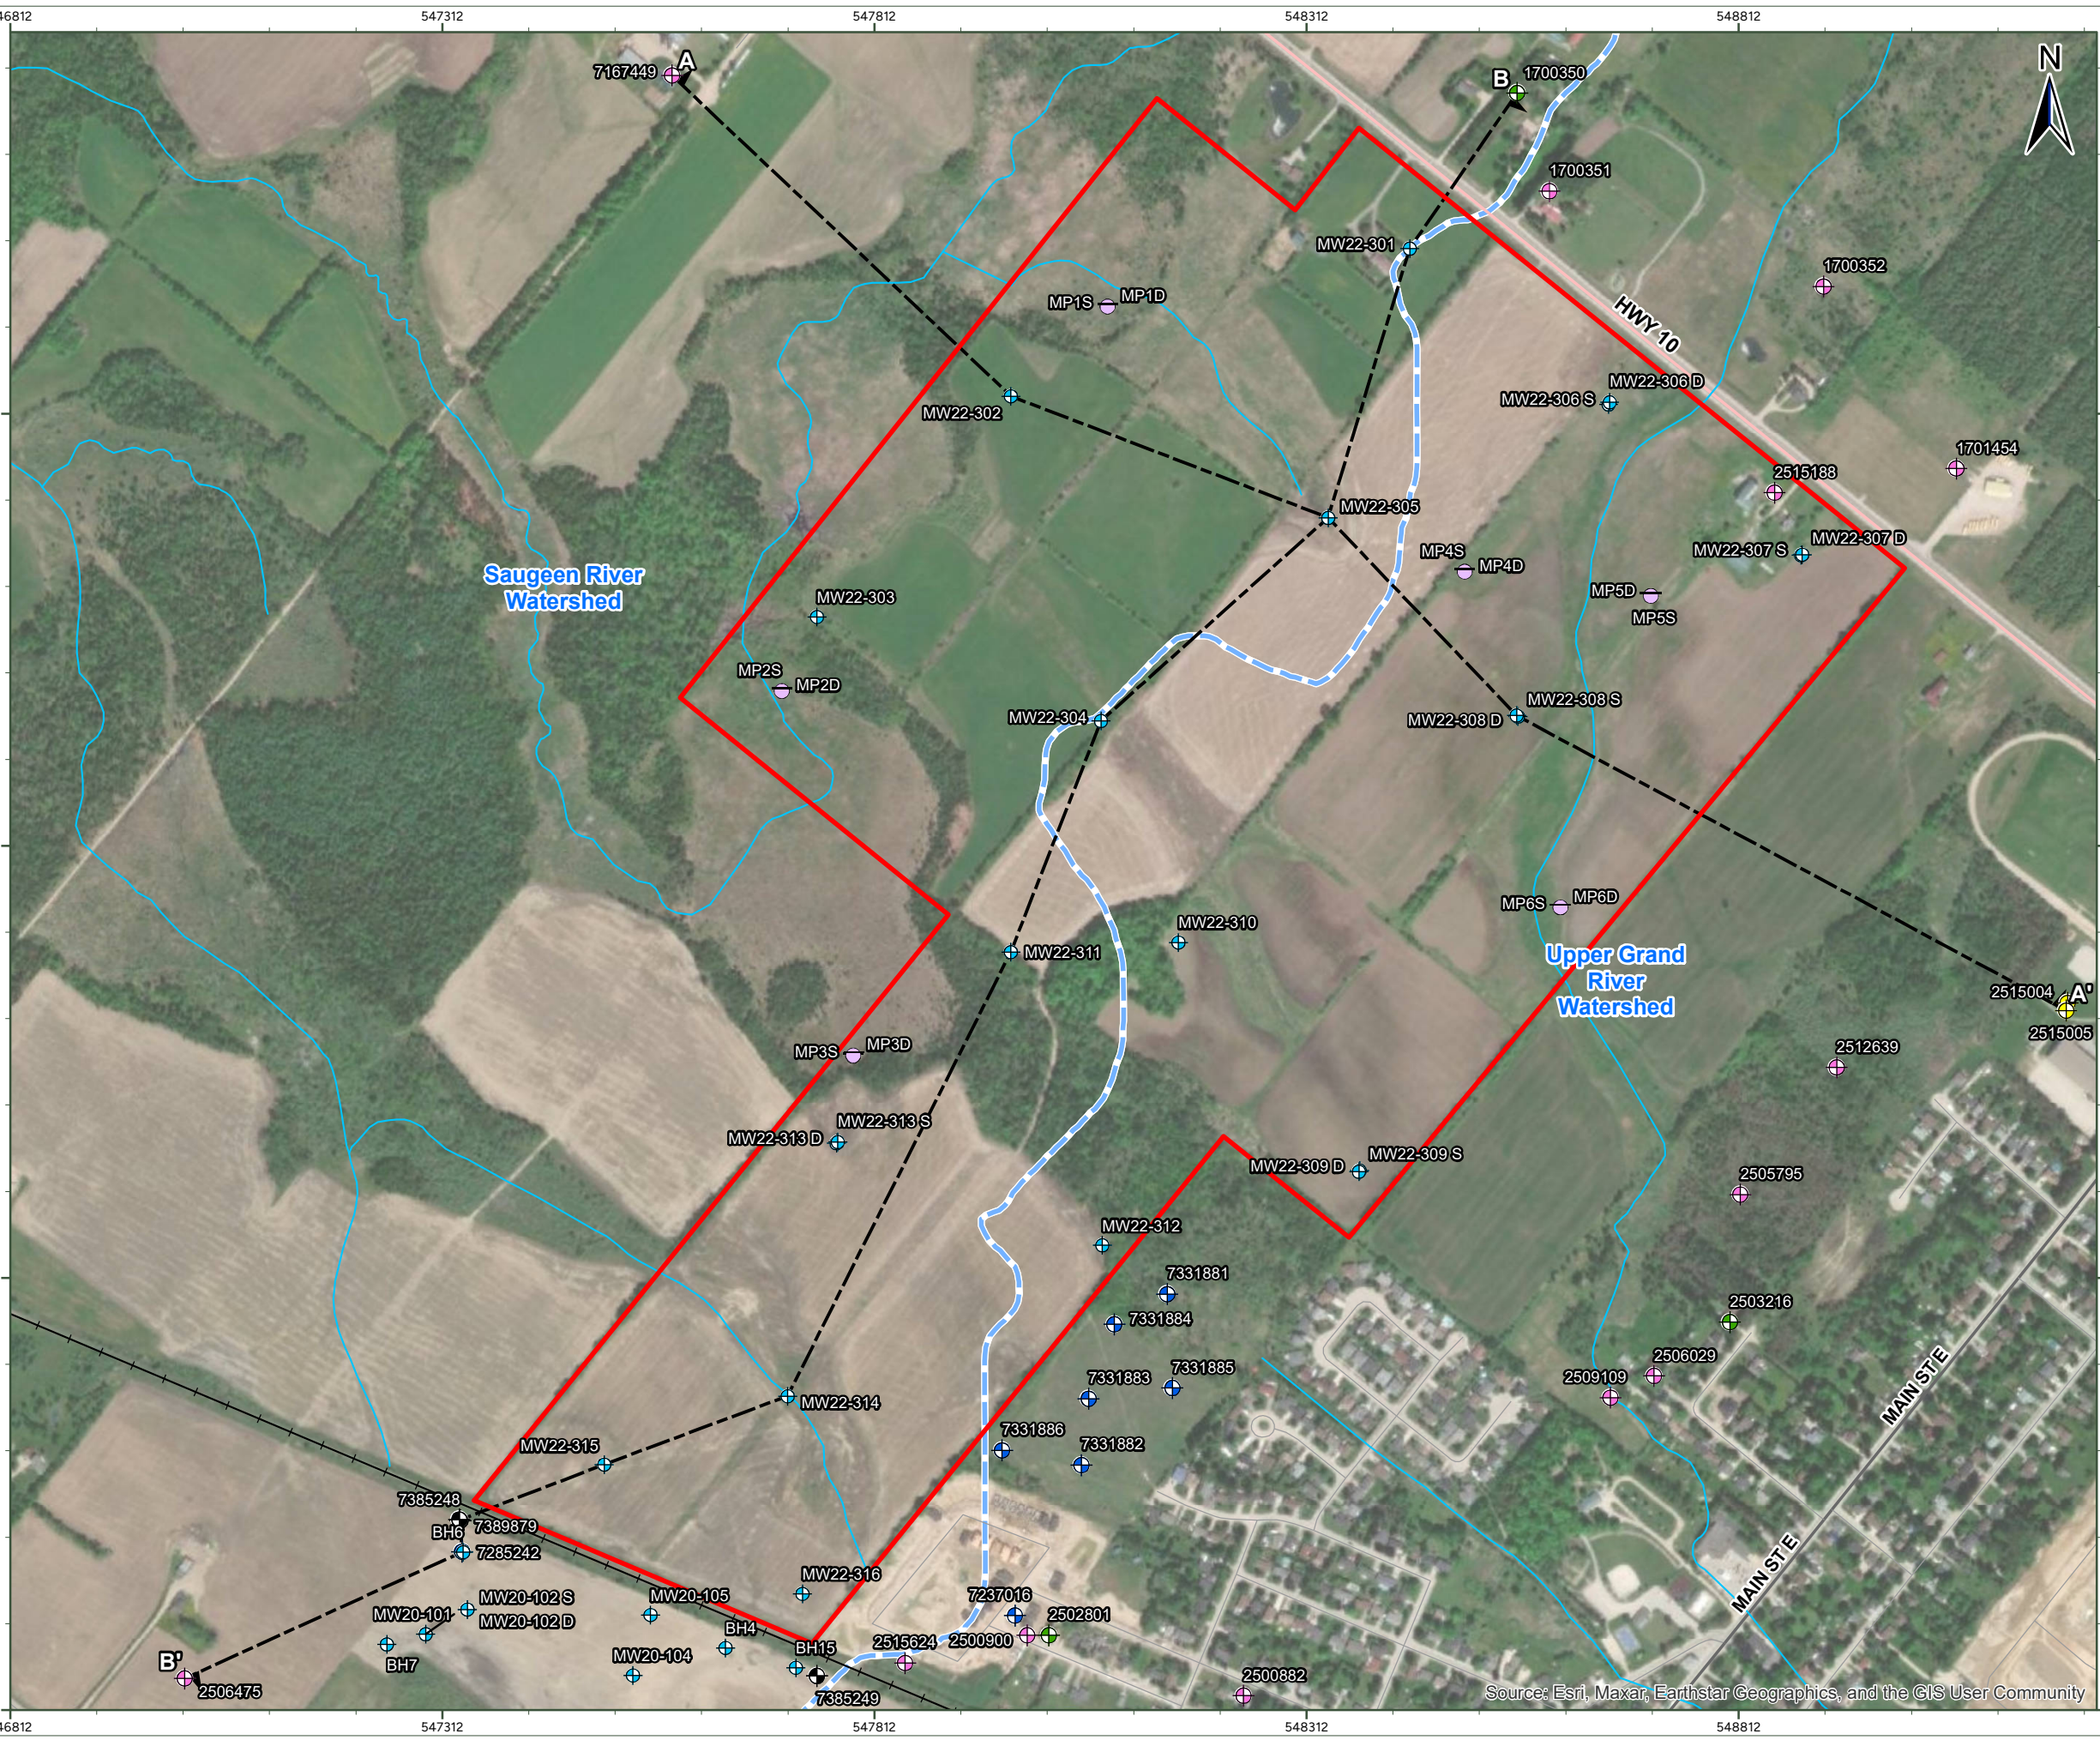
- SITE BOUNDARY
- + MONITORING WELL
- + MINI-PIEZOMETER
- MECP WELL LOCATION (WWIS, 2022)**
- + LIVESTOCK
- + MUNICIPAL
- + MONITORING
- + DOMESTIC
- + UNCLASSIFIED
- PERMANENT WATERCOURSE
- DRAINAGE DIVIDE
- CROSS SECTION
- RAIL TRAIL

Surficial geology of the Study Area was also characterized by advancing boreholes at select locations across the property. Borehole logs are provided in **Appendix B**. Geological cross-sections of the Study Area, as indicated in **Figure 7**, are presented in **Figure 8** and **Figure 9**.
